GROUND SUBSIDENCE AND ACTIVE FAULTS IN THE HOUSTON METROPOLITAN AREA

HGS/ECH Conference On Coastal Subsidence, Sea Level And The Future Of The Gulf Coast

**HGS/ECH
GROUND SUBSIDENCE AND ACTIVE FAULTS
IN THE HOUSTON METROPOLITAN AREA
November 5, 2005**

Ground Subsidence and Active Faults in the Houston Metropolitan Area

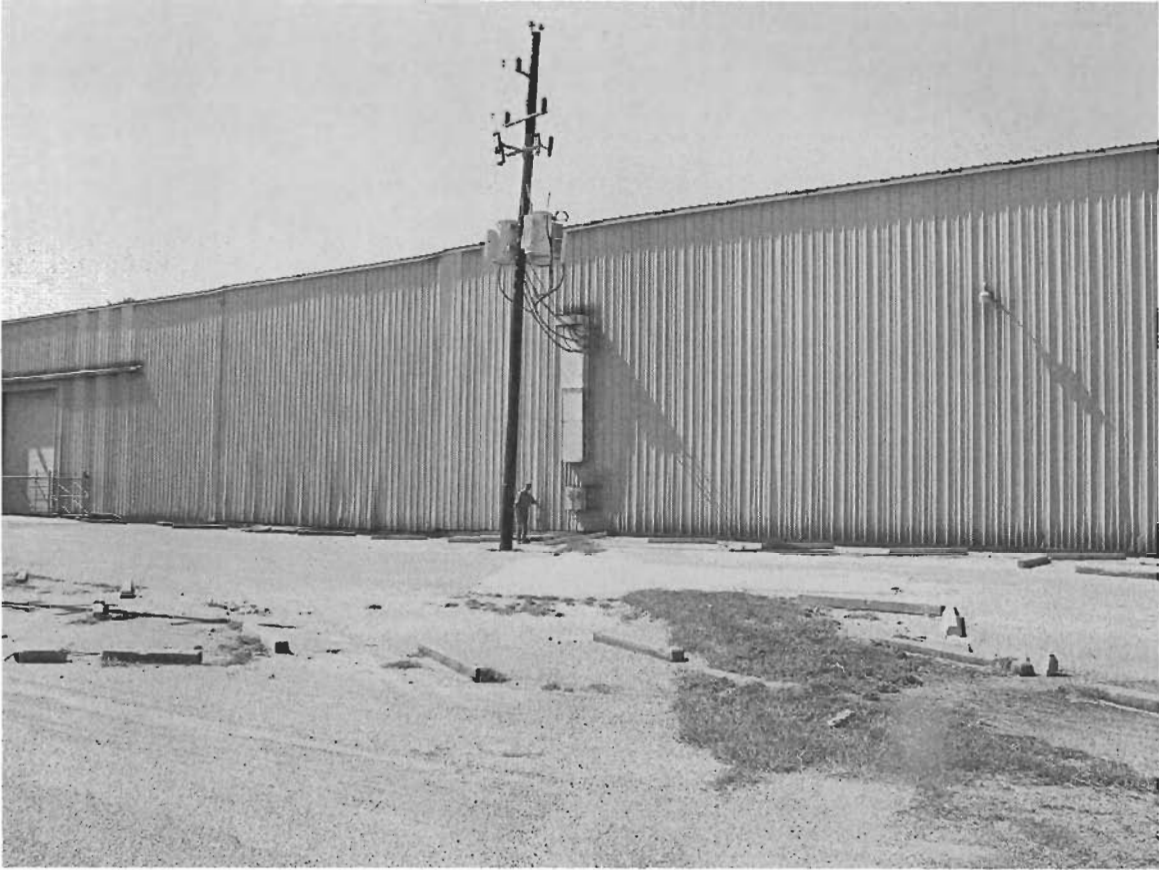
2005 – Brittmoore Fault. View to Southwest

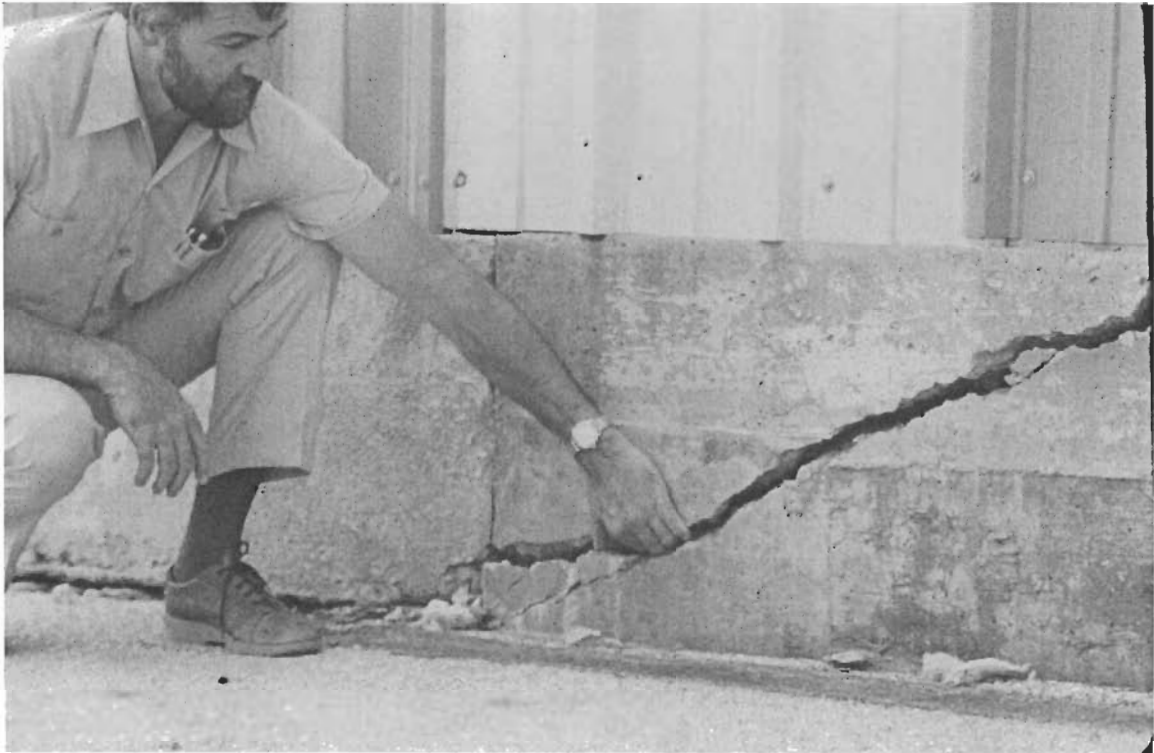
1978 – Brittmoore Fault. Crack in Foundation at Edge of Upthrown Fault Block

At Stop 2 the Brittmooore Fault passes beneath a large warehouse with a massive foundation, built after October 1964 and before March 1972, to withstand the weight of stacked oil field pipe. The 1978 photograph on the previous page shows a through-going open crack in the 2-foot exposed portion of the steel-reinforced foundation. It is a sobering display for those contemplating construction of a foundation that will withstand fault movement. The portion of the foundation along the fault was reconstructed about 15 years ago. Since then it has bent, but not cracked as it surely will if the fault remains active.

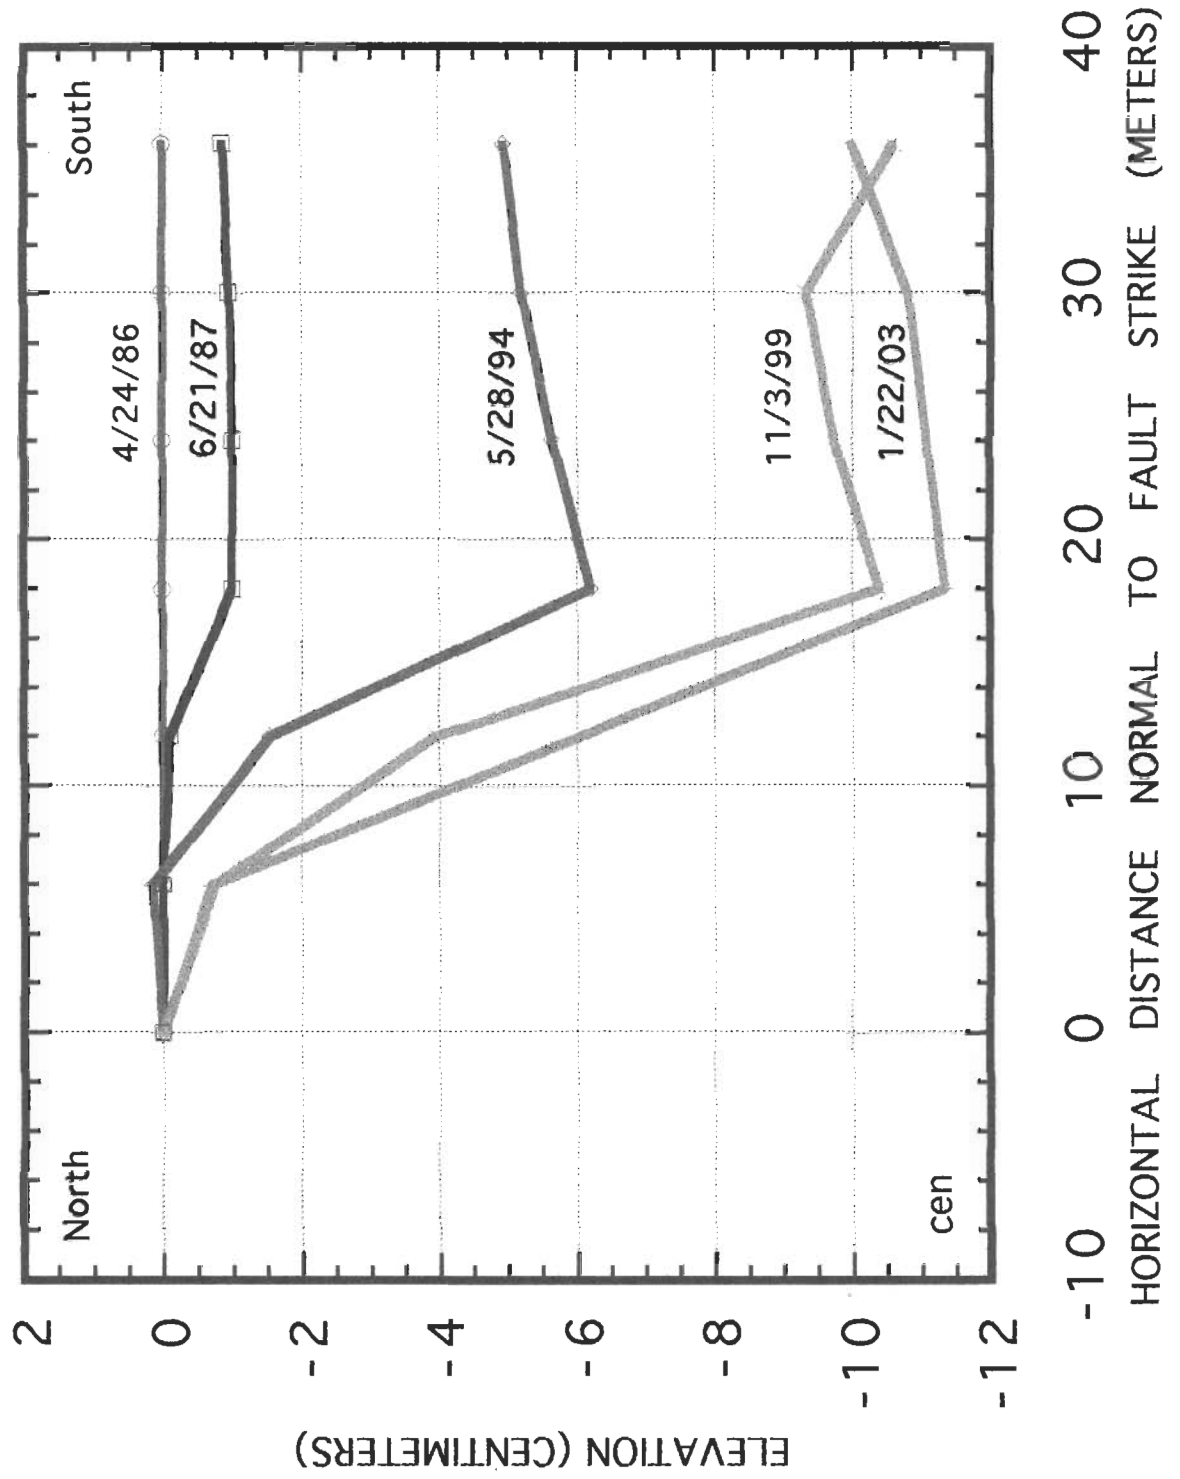
BRITTMOORE FAULT
 FISHER STREET AT WEST LITTLE YORK ROAD
 ELEVATION CHANGES, 4/24/86 THROUGH 1/22/03

The following 2 pages are graphs of data obtained from repeated measurement of changes in elevation of bench marks placed with 25-foot spacing in the asphaltic concrete pavement along the east side of Fisher Street. You will be able to see most of them today. The first diagram shows displacement vs. distance along the 150-foot line over a period of nearly 17 years. This type of plot is useful for determining the width of the zone of disturbed ground along the fault. The second diagram shows vertical displacement vs. time between the lowest and highest bench marks. From 1986 through 1999 movement was at a nearly constant rate of 0.33 inches per year. It then slowed to 0.1 inches per year. This location is just southeast of Jersey Village, where the Harris-Galveston Coastal Subsidence District reports accelerated subsidence due to excessive pumpage of groundwater. Does an increase in the rate of subsidence cause a decrease in rate of fault movement?

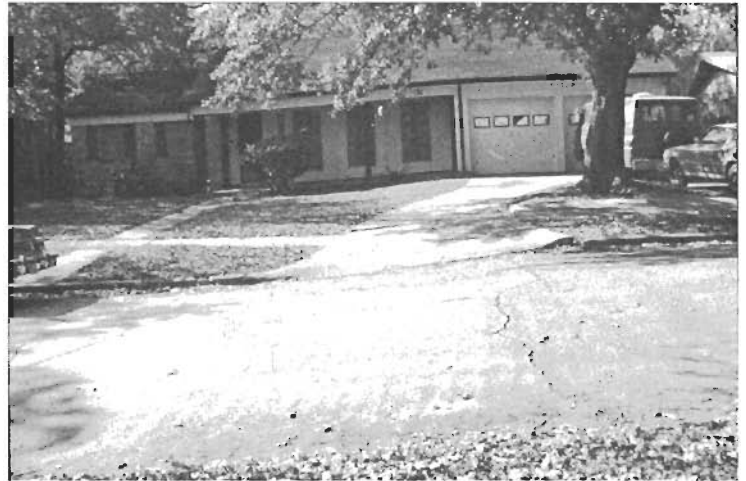
The top photograph was taken in 1977. The sag along the roofline indicates that the foundation has been broken by fault movement. The fault is visible in the foreground of the photo where it has warped and cracked the street surface.

1977: House with broken foundation
(photo by E. Clanton)

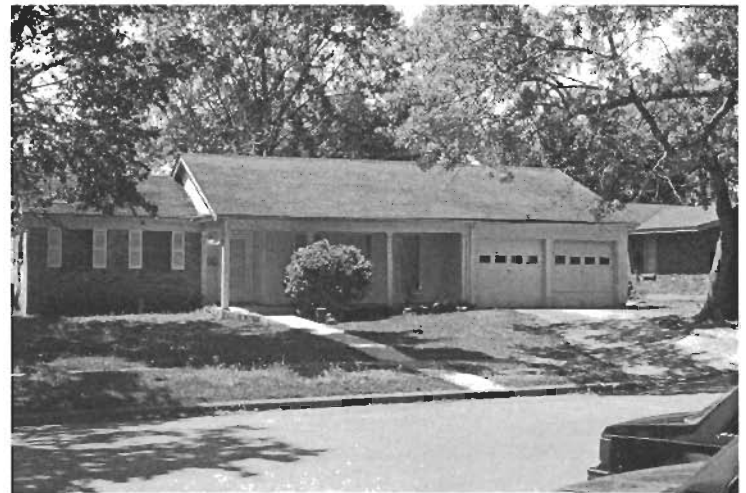
The middle photograph was taken in 1984, five years after the foundation was leveled and repaired in 1979. Close inspection of the picture reveals a sag in the roofline which is a result of continued fault movement.

1984: House 5 years after foundation repair
(photo by C. Norman)

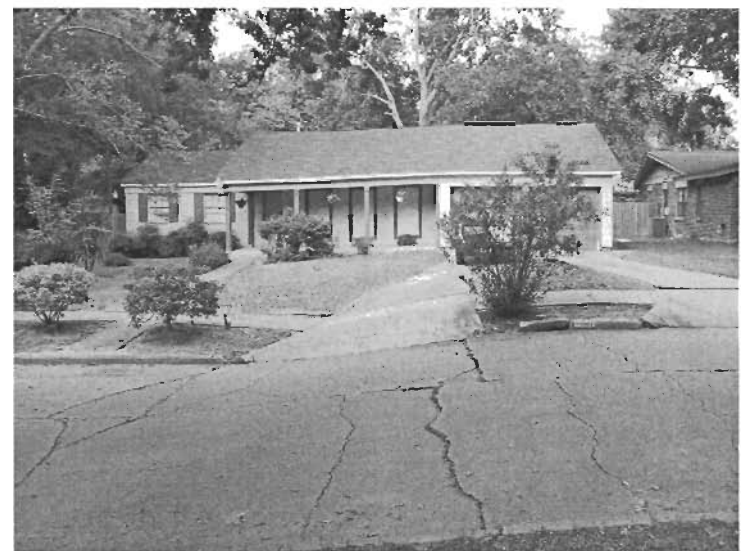
The roofline in the bottom picture shows that by 2003 the damage to the foundation is almost what it was back in 1977. Again, the fault is visible in the foreground of the picture.

Repeated repairs to a building's foundation and structure ultimately make the cost of occupancy prohibitive. Failure to perform continual repairs to the foundation can ultimately lead to structural failure that can in turn threaten the safety of any occupants.

2003: House with recurring foundation problems
(photo by TSI)

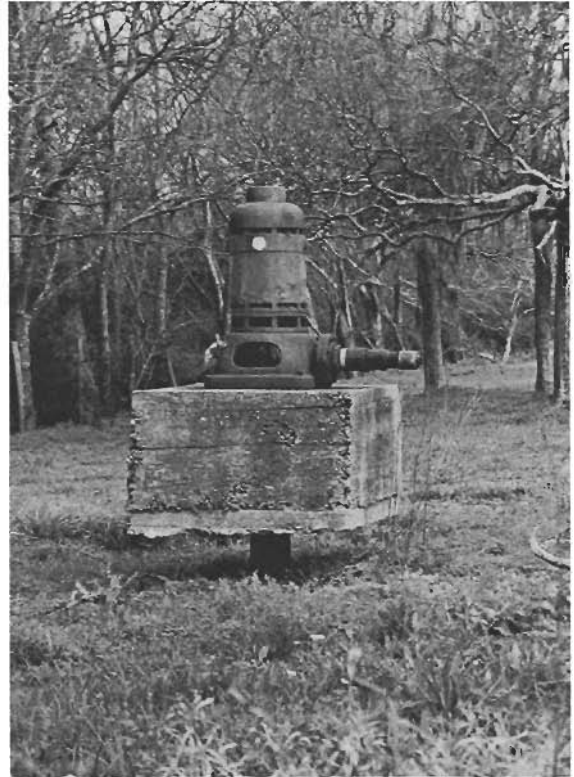
1986

A brief stop at the former site of the Burnett School reveals an interesting phenomenon. Behind the former school site is an old utility district supply well which is unique in that it has behaved like an extensometer. The casing of this well has been set at approximately 500 feet (152 m) below the land surface. In this particular case, the bottom of the casing has remained stable at the point at which it was originally set, and the ground has subsided around it. This phenomenon, while interesting, is not a common one because the friction of the strata on the well casing will often cause compressive failure. Close inspection of the concrete well pad would seem to indicate that as the ground subsided around the well, the utility made several more pours of concrete to fill the gap between the old pad, which was suspended in mid-air, and the ground surface. For this reason, it is nearly impossible to determine the exact amount of compaction that this well is showing us, but certainly it is on the order of several feet.
