GROUND SUBSIDENCE AND ACTIVE FAULTS IN THE HOUSTON METROPOLITAN AREA

HGS/ECH Conference On Coastal Subsidence, Sea Level And The Future Of The Gulf Coast

**HGS/ECH
GROUND SUBSIDENCE AND ACTIVE FAULTS
IN THE HOUSTON METROPOLITAN AREA
November 5, 2005**

Ground Subsidence and Active Faults in the Houston Metropolitan Area

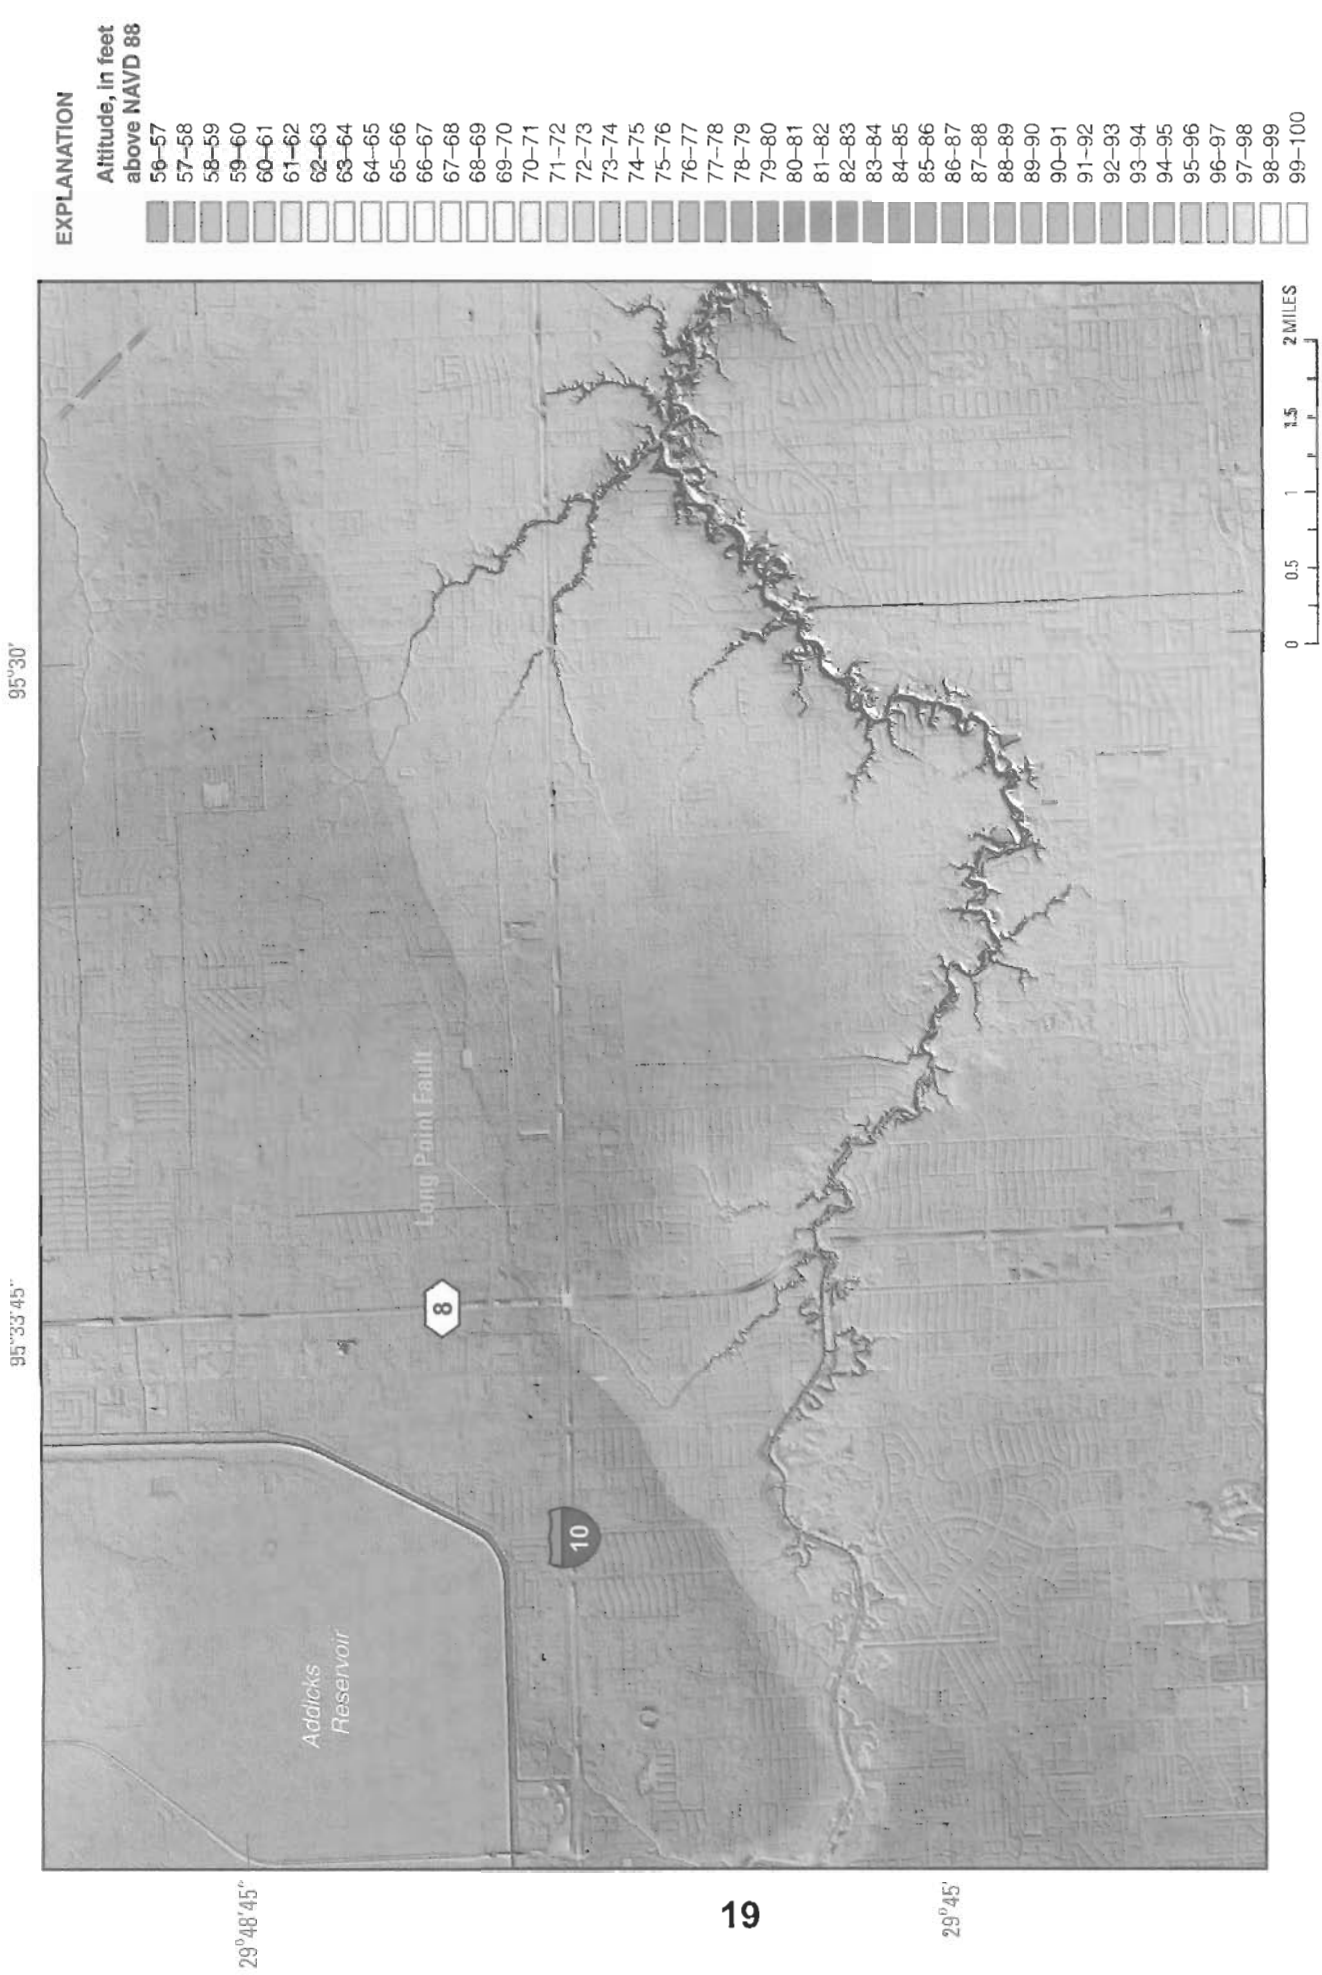
Figure 3. Segment of the hillshaded 15-foot bare-earth Lidar-derived digital elevation model of the area of Harris County showing the Long Point fault.
 From PRINCIPAL FAULTS IN THE HOUSTON, TEXAS, METROPOLITAN AREA (Shah and Lanning-Rush, 2005)

The Long Point Fault is the longest single-segment fault in the Houston area. It extends 10.3 miles across west Houston from the vicinity of Eldridge Parkway at Whittington northeastward to a point near Hempstead Highway and Dacoma. Data from a seismic profile shows the fault to a depth of at least 17,000 feet. It is a typical concave-upward growth fault. From measurements of the vertical displacement of originally horizontal home foundations, the rate of movement of the fault in this area in the 1950's through 1970's was slightly more than 1 inch per year. Since that time it has slowed considerably, but nevertheless is still active. Generally rates of movement are highest near the centers of surface faults, decreasing to zero at their ends. This fact is well illustrated by the LIDAR photograph of the Long Point Fault on the next page.
