## STOPS 1 & 2

### ACTIVE FAULTS IN NORTH HARRIS COUNTY AND SOUTH CENTRAL MONTGOMERY COUNTY, TEXAS

Carl E. Norman  
Department of Geosciences, University of Houston

Bill R. Elsbury  
Fugro-McClelland (Southwest), Inc., Houston, Texas

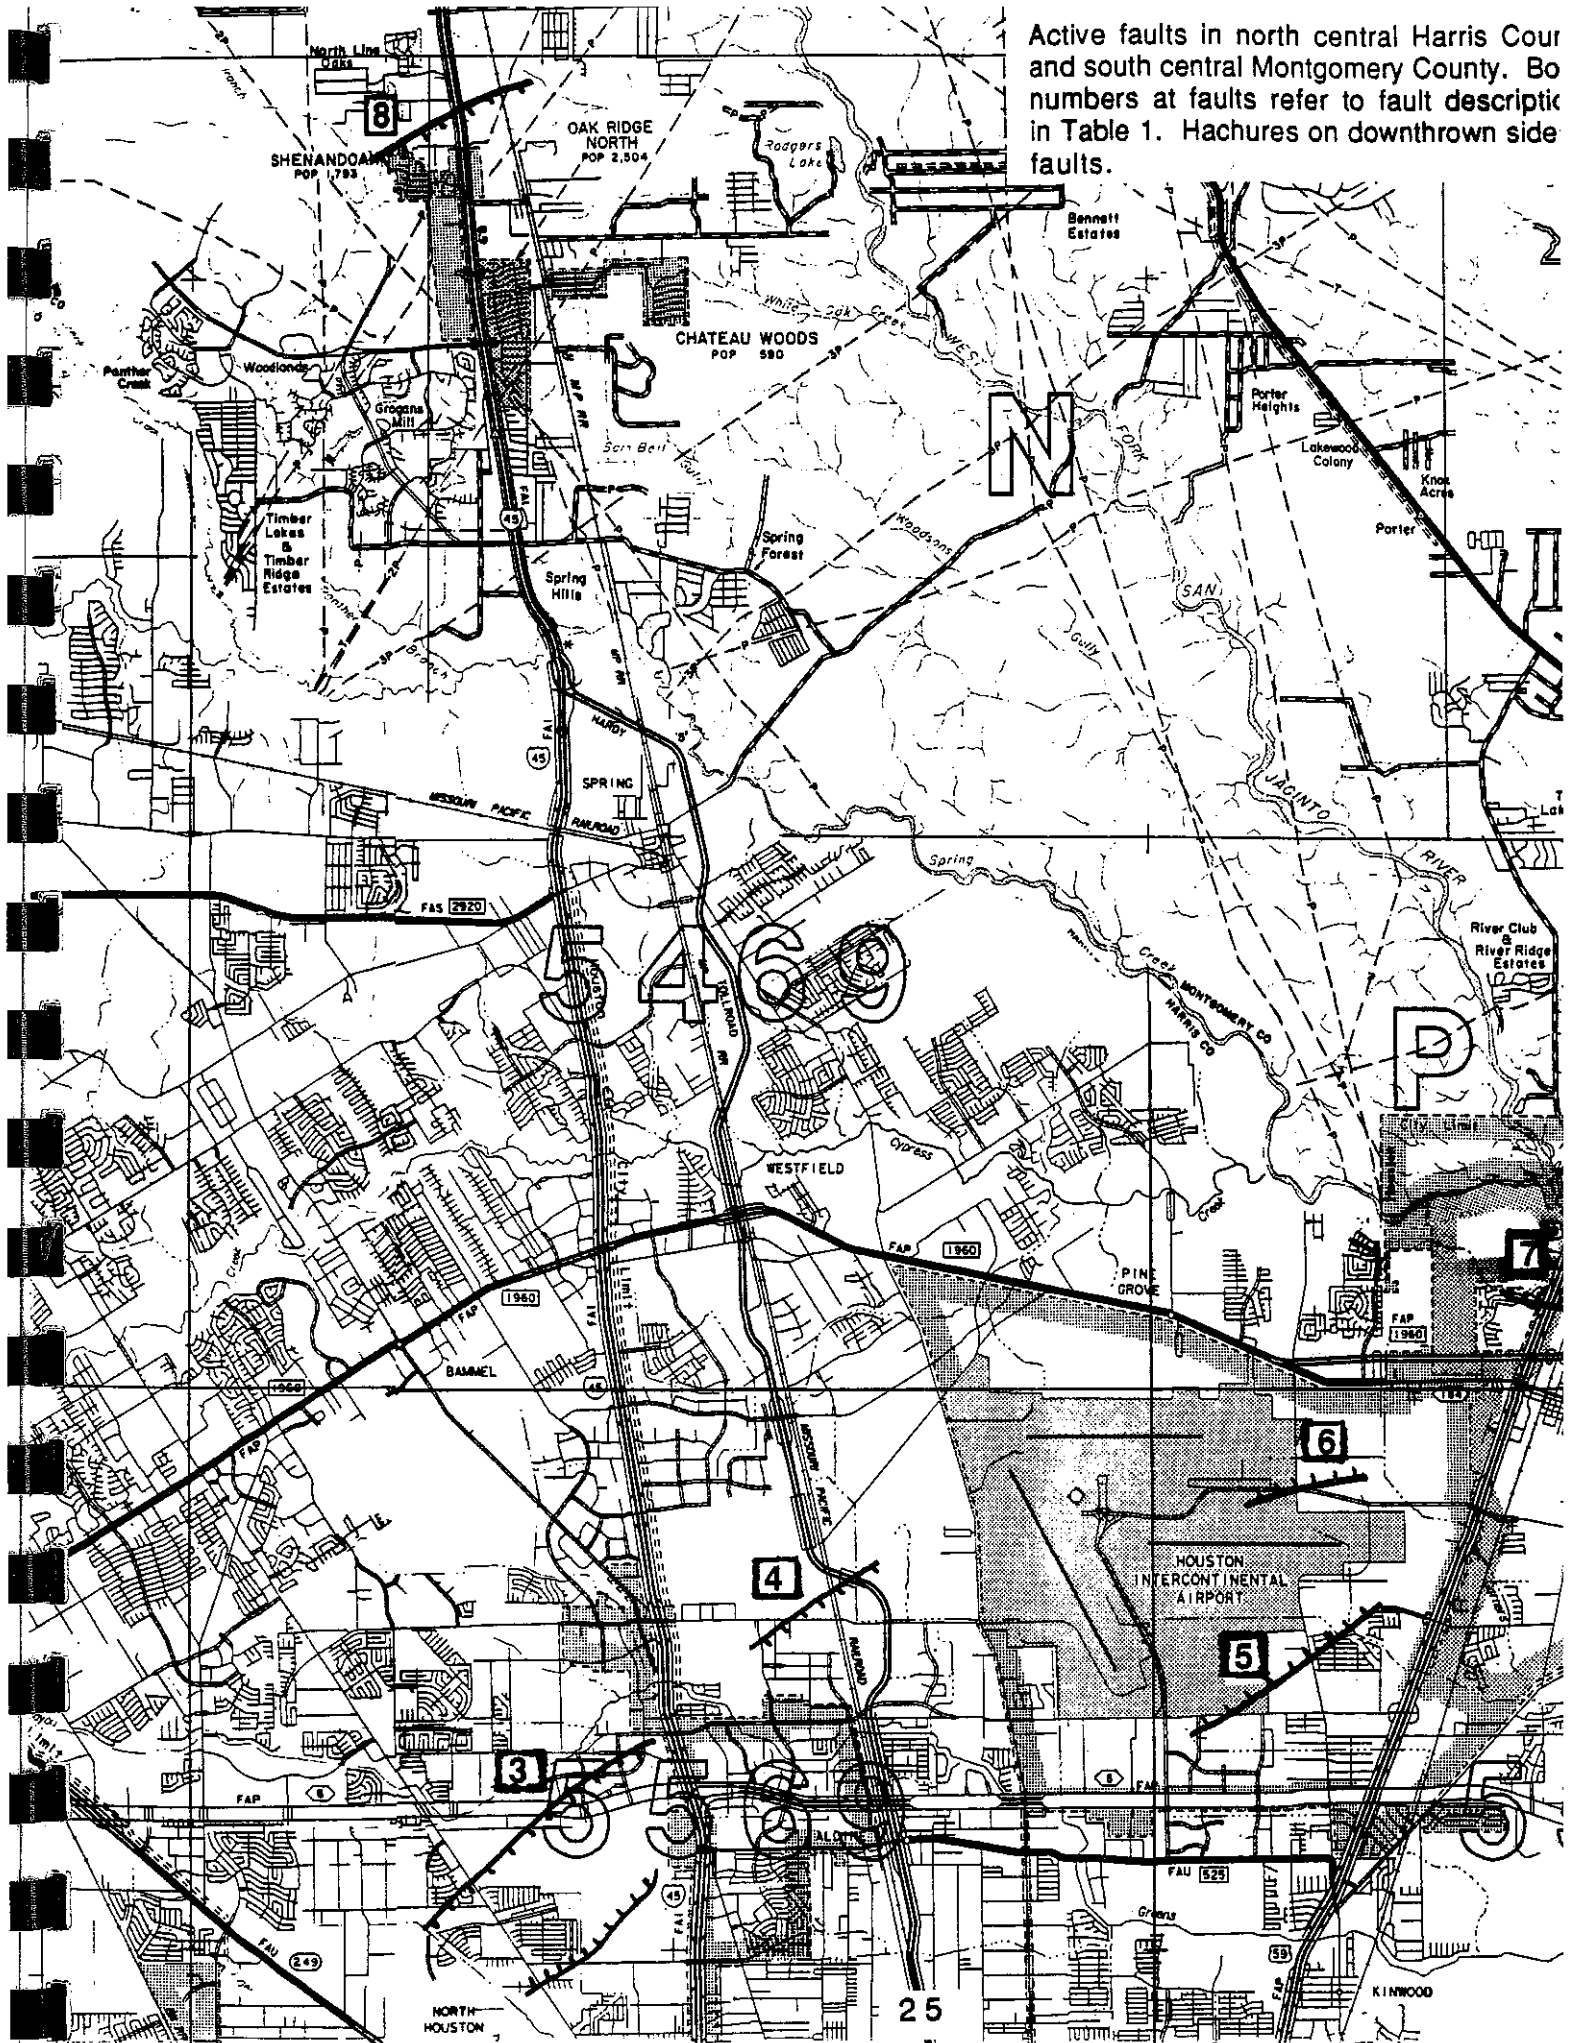
Active faults in north central Harris County and south central Montgomery County. Bo numbers at faults refer to fault descriptive in Table 1. Hachures on downthrown side faults.

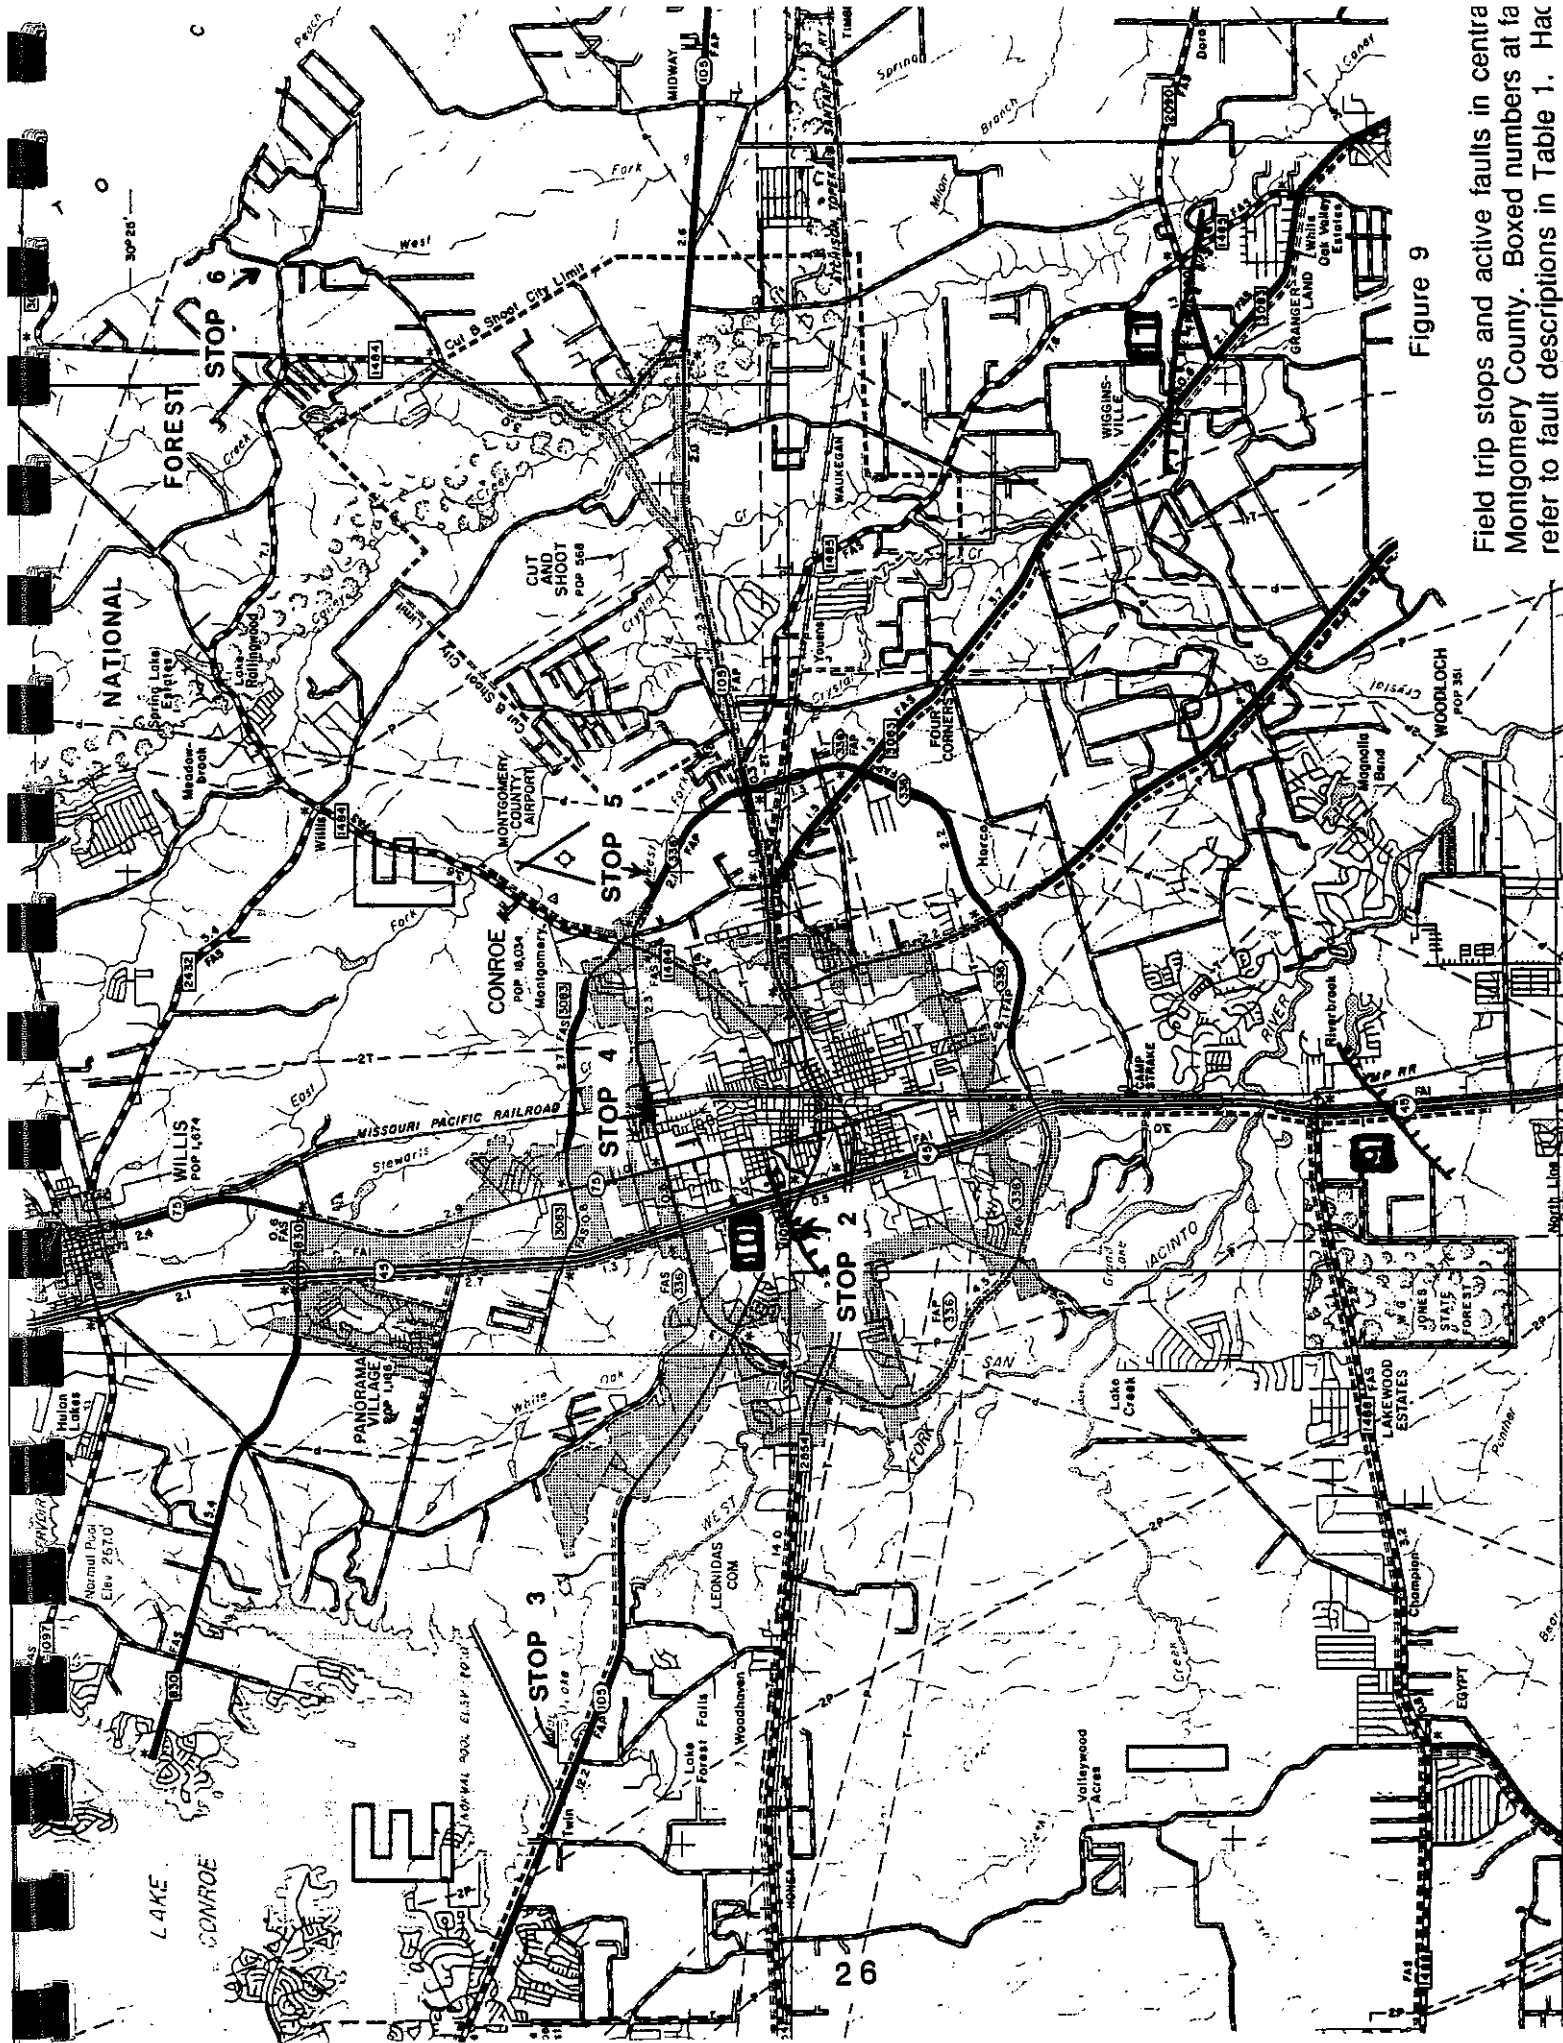
Figure 9

Field trip stops and active faults in central Montgomery County. Boxed numbers at fault refer to fault descriptions in Table 1. Hac
